HITLER'S TANKS

GERMAN PANZERS OF WORLD WAR II

EDITED BY
CHRIS McNAB

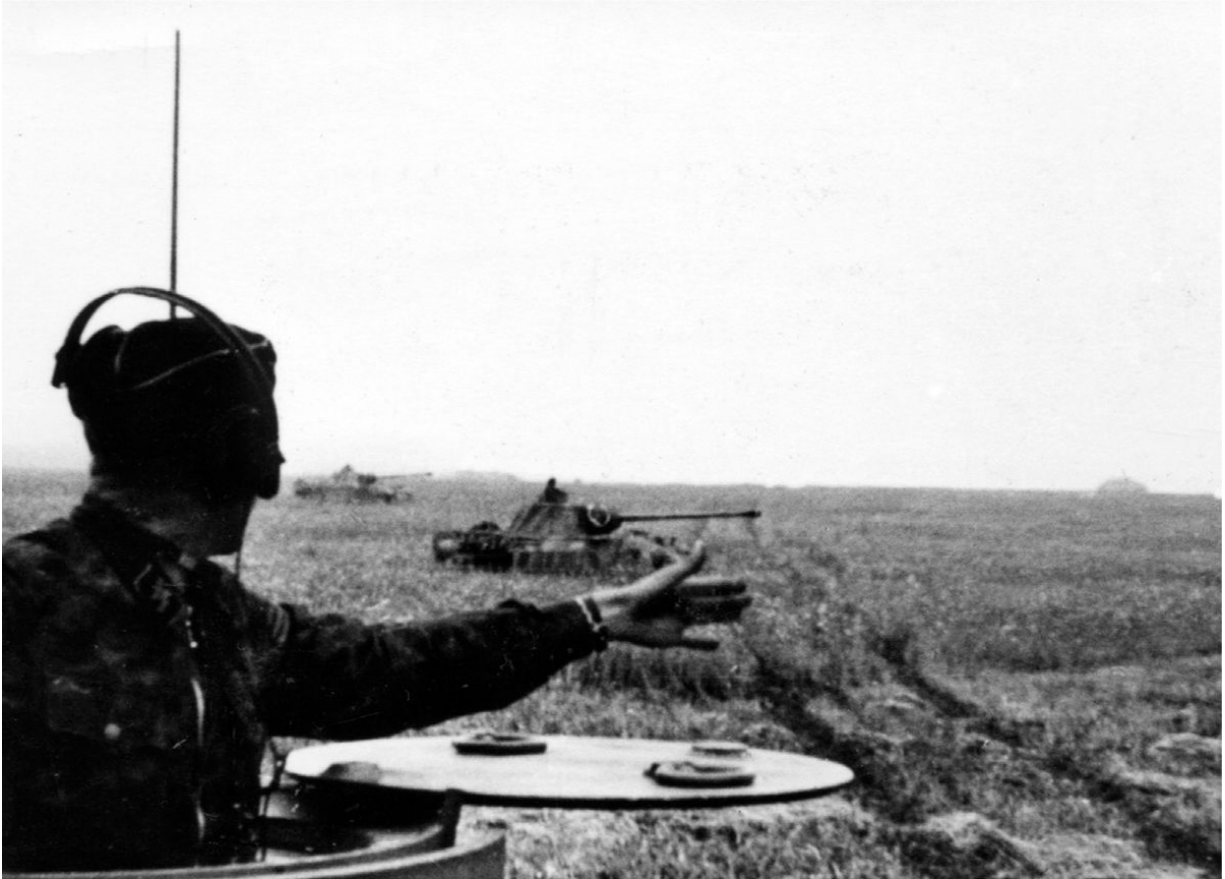
Das Reich Division Panthers push forward in a line on the Eastern Front during fighting around the Kursk salient in 1944. These tanks do not have the optional machine gun fitted to the commander's cupola. (AirSeaLand/Cody)

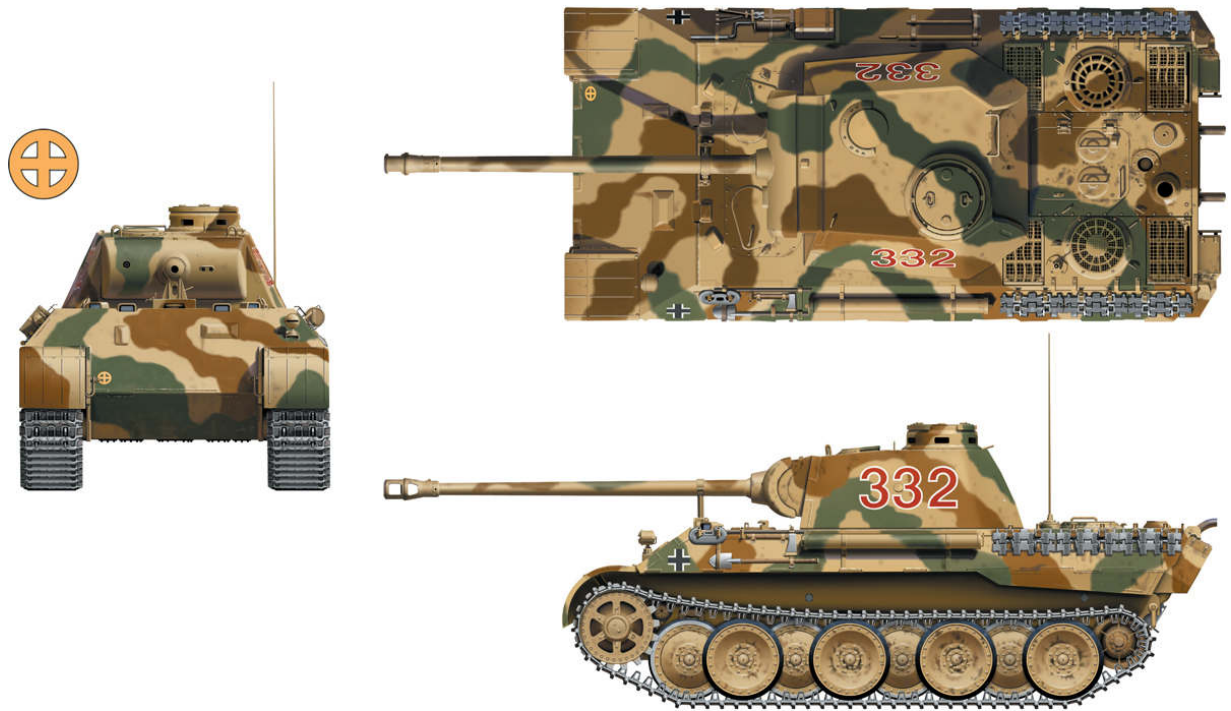
(Jim Laurier © Osprey Publishing)

Six features distinguish this vehicle as a late Ausf D. First, the tank has only one headlamp, on the left. Second, it lacks the circular communications hatch fitted to the left-hand side of turret. Third, its road wheels have 24 rim bolts instead of 16. Fourth, it has an additional ring mounted on the commander's cupola onto which an anti-aircraft machine gun could be fitted. Fifth, the vehicle has a wide rain guard mounted over the TZF 12 binocular gun sight on the turret mantlet to keep out driving rain. Finally, the tank has improved tracks with chevron cleats for enhanced traction in the muddy conditions prevalent on the Eastern Front during autumn. It is interesting to note first that the tank lacks Schürzen side skirts, and second, given the absence of a rippled finish to the vehicle's exterior, that the tank had not been coated with Zimmerit anti-magnetic mine paste, which during this period was increasingly being applied in the field.

During September 1943, the lessons learned from the disappointing debut of the Panther at Kursk led to further modifications to the last Ausf D tanks of the original 850-unit production run. Many of the last 37 Ausf D Panthers produced in September, for example, featured Zimmerit anti-magnetic mine paste, a substance that hindered Soviet infantry from placing magnetic hollow-charge devices onto the tanks' surfaces. In addition, the late Ausf D tanks had two new features – a rain guard mounted over the gun sight on the turret mantlet to keep out driving rain, and improved tracks that sported chevron cleats for enhanced traction.

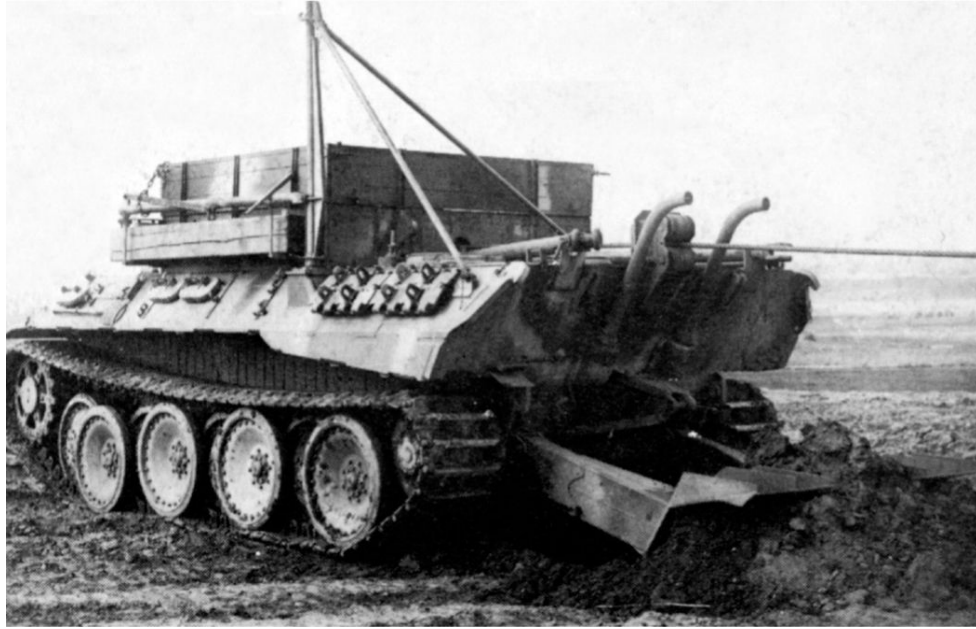
The Bergepanther was an armoured recovery vehicle, built upon the Panther chassis. Note here how the rear spade is braced in the earth for stability during a winching operation.
(AirSeaLand/Cody)

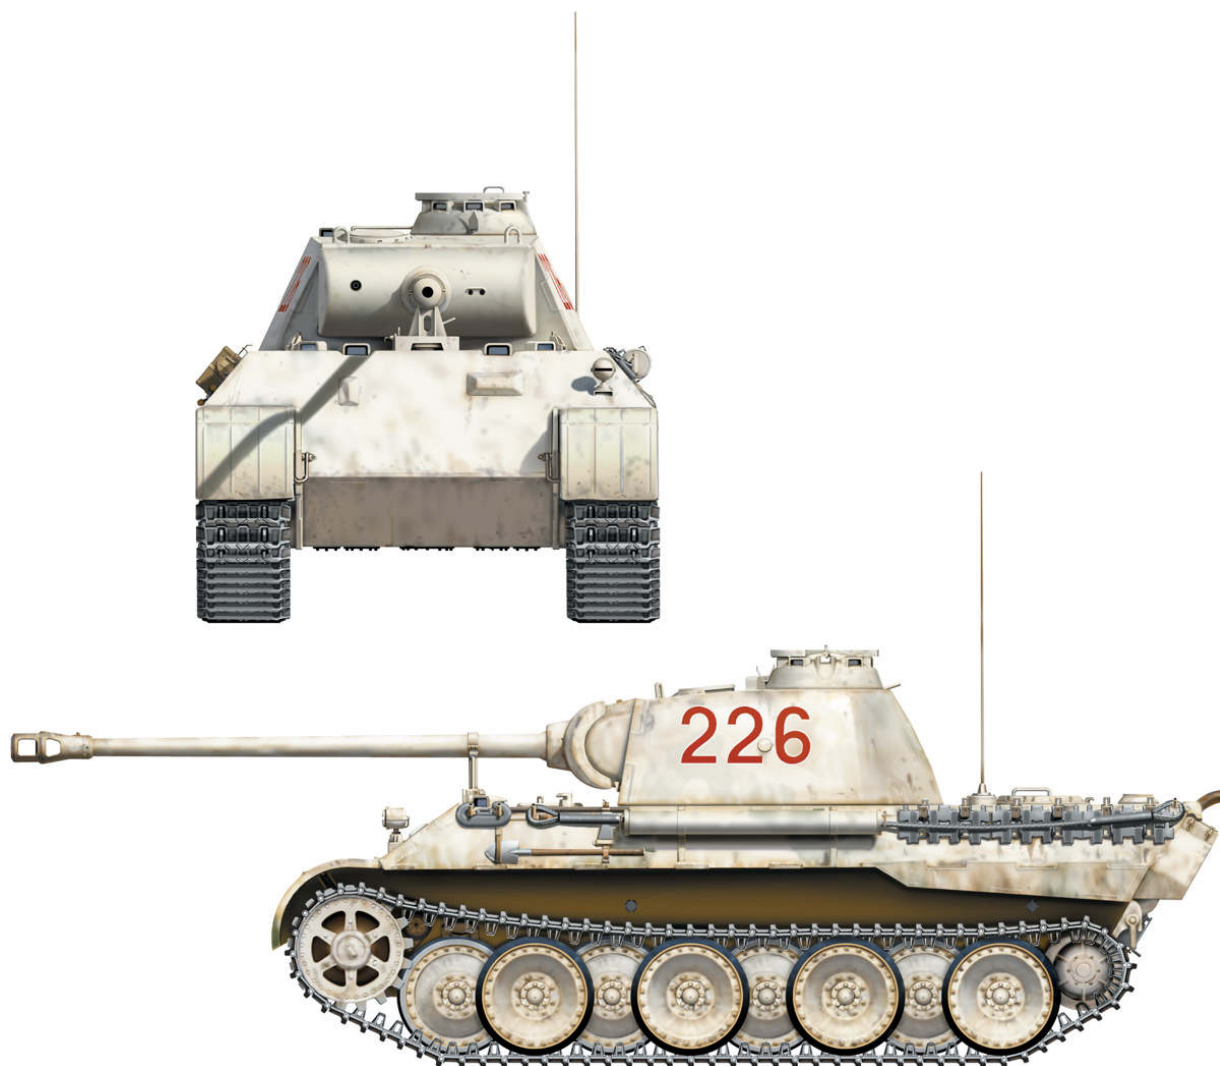
**VIEW OF WHITEWASHED EARLY
PANTHER AUSF A; EASTERN
FRONT, WINTER 1943-44**

This plate depicts an early Ausf A Panther deployed on the Eastern Front during winter 1943–44. The Ausf A tank was essentially an Ausf D chassis mounted with a new turret. The most obvious new feature, in comparison with the Ausf D, is the new cast commander's cupola on the left rear of the turret. This cupola has an entirely new hemispherical shape and has seven armoured periscopes to enhance the commander's field of vision. A more subtle distinction between this Ausf A and its predecessor can be seen where the side turret plate interlocks with the turret front plate just behind the mantlet; on this tank, this joint is square-cut, whereas in Ausf D tanks the joint was dovetailed.

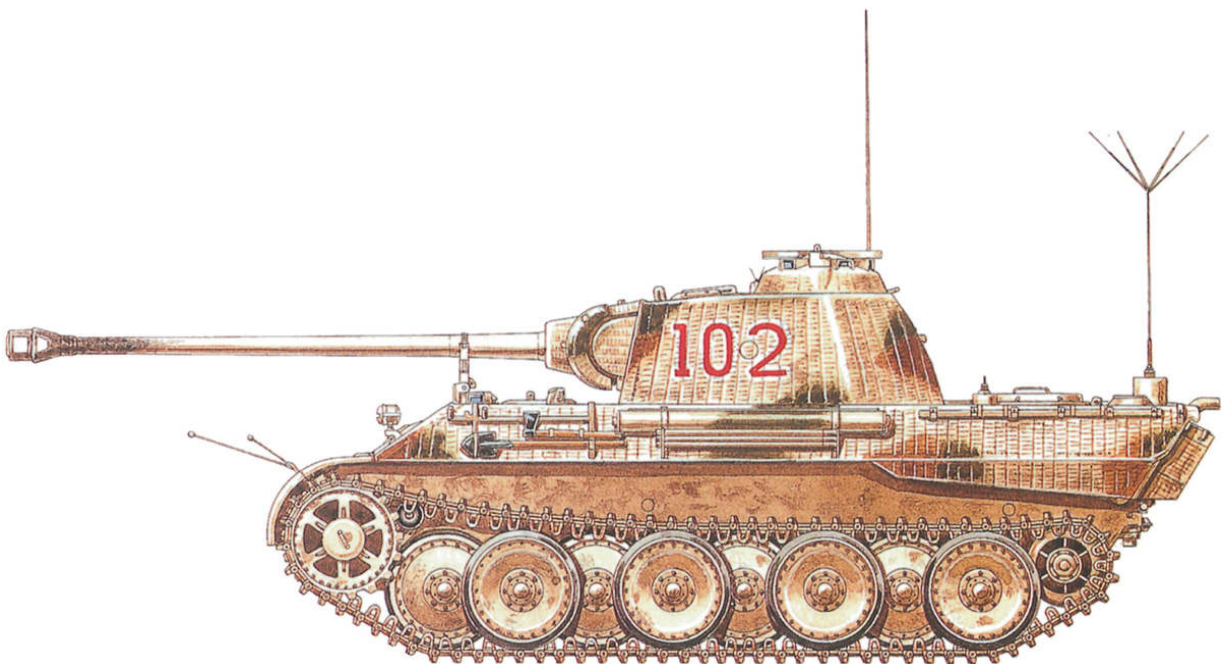
1) Panther Ausf A as Panzerbefehlswagen, Panzer-Regiment 4; Anzio, Italy, 1944. This Panzerbefehlswagen was assembled by MAN in October/November 1943 and was one of the 76 Panthers brought to Italy by the I. Panzer-Regiment 4 in February 1944.

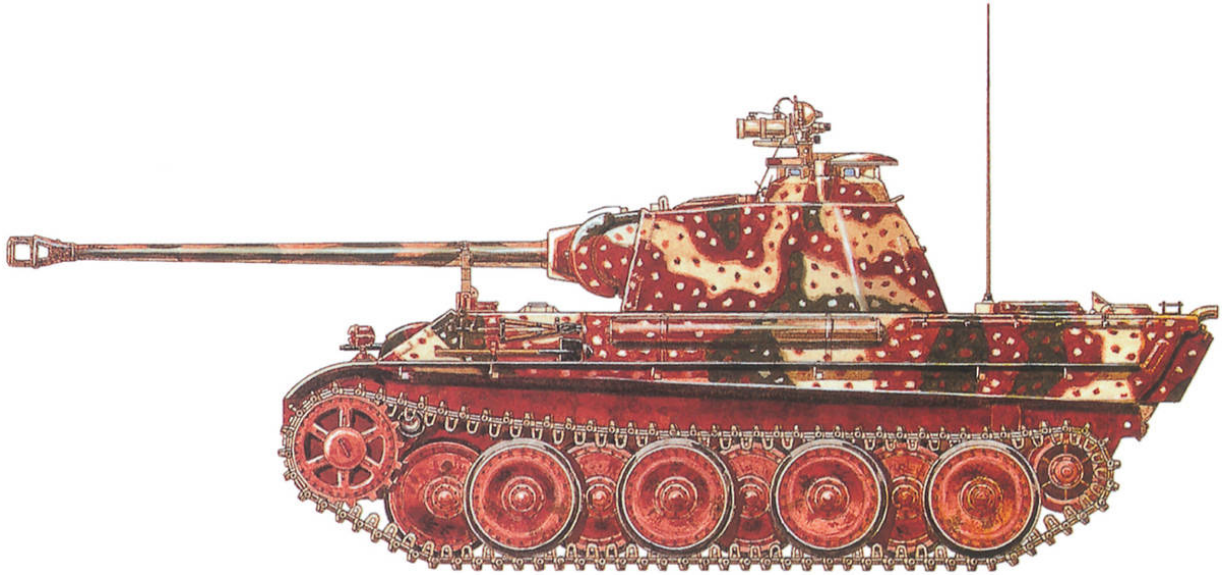
2) Panther Ausf G Mit Fg 1250; October 1944. This Panther Ausf G was built in October 1944 with all the modifications necessary for mounting night-fighting equipment: infra-red sights and illumination devices. The FG 1250, consisting of an infra-red sight and searchlight, was mounted in the commander's cupola and slaved to the main gun.

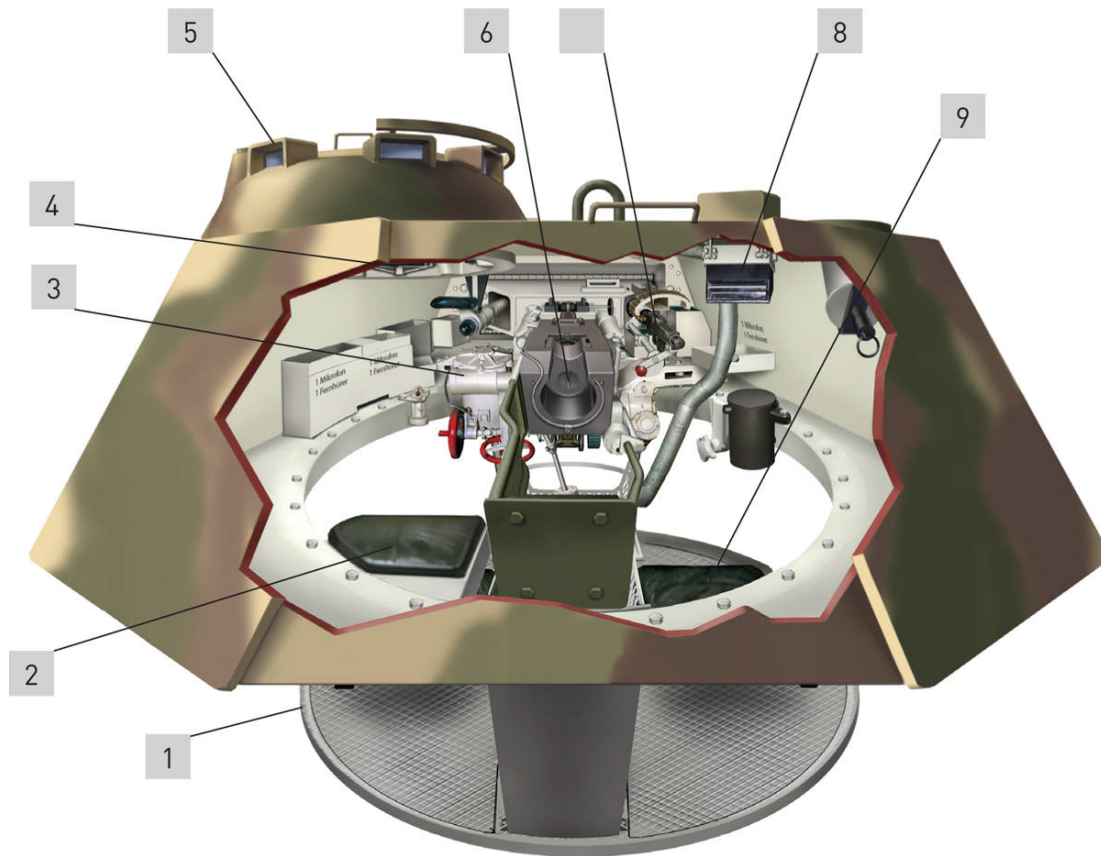
PZKPFW V PANTHER TURRET

- 1.** Rotating turret basket floor
- 2.** Gunner's seat
- 3.** Gunner's fire controls
- 4.** Gunner's periscopic sight
- 5.** Commander's vision cupola
- 6.** 75mm gun
- 7.** Co-axial machine gun
- 8.** Loader's periscopic sight
- 9.** Loader's seat

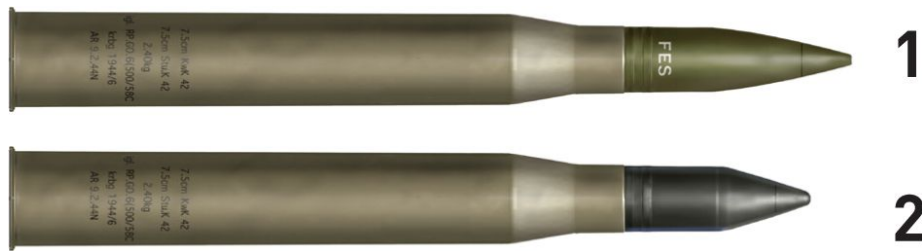
PZKPFW V AMMUNITION

1. Sprgr 42 (HE)
2. Pzgr 39/42 (AP)

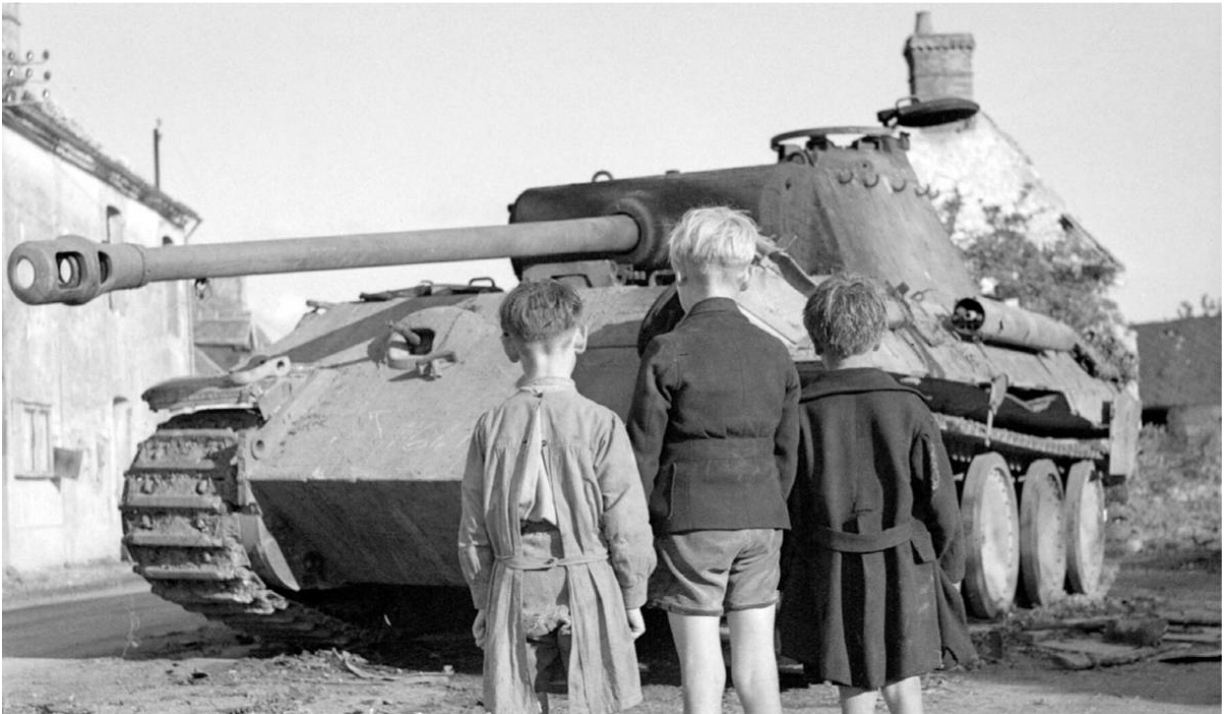
Three French schoolboys study a destroyed Panther in the Falaise Pocket, France, 22 August 1944. The hooks along the side of the turret could be used to mount Schürzen armour plate or hang supplies, equipment or camouflage. (AirSeaLand/Cody)

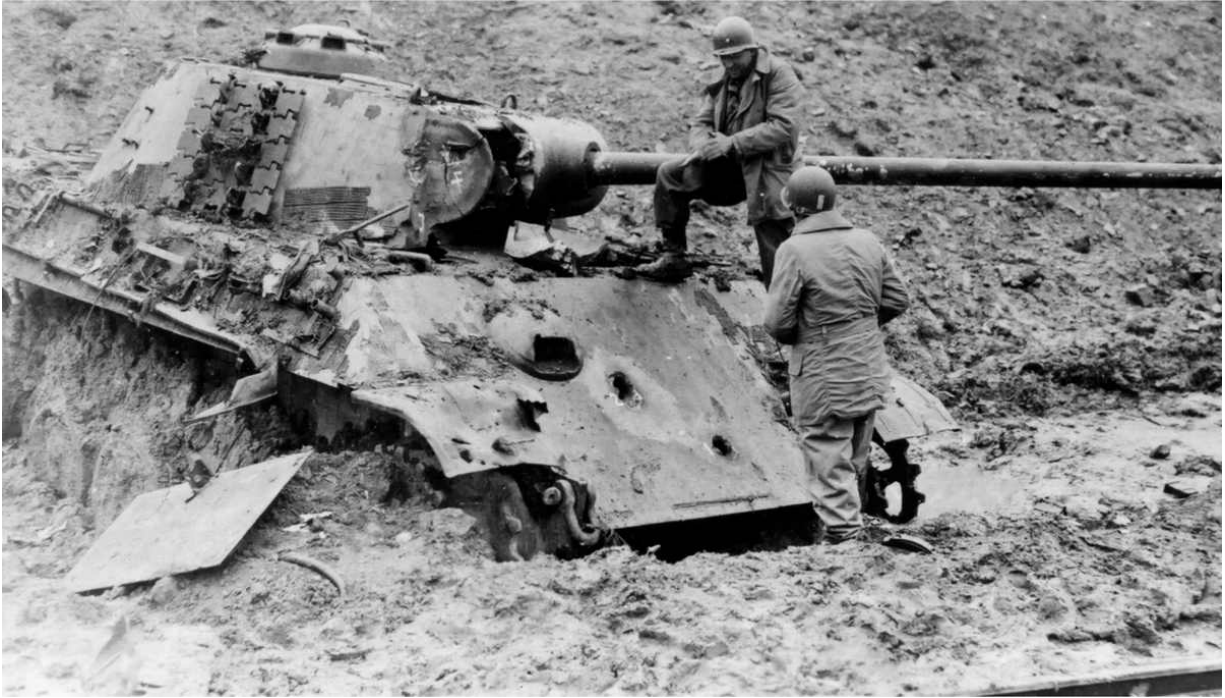
This captured PzKpfw V Panther Ausf G was used by US forces to test out the new 90mm gun that would be used on the M26 Pershing. As is evident here, the rounds have gone clean through both front hull armour and the gun mantlet. (AirSeaLand/Cody)

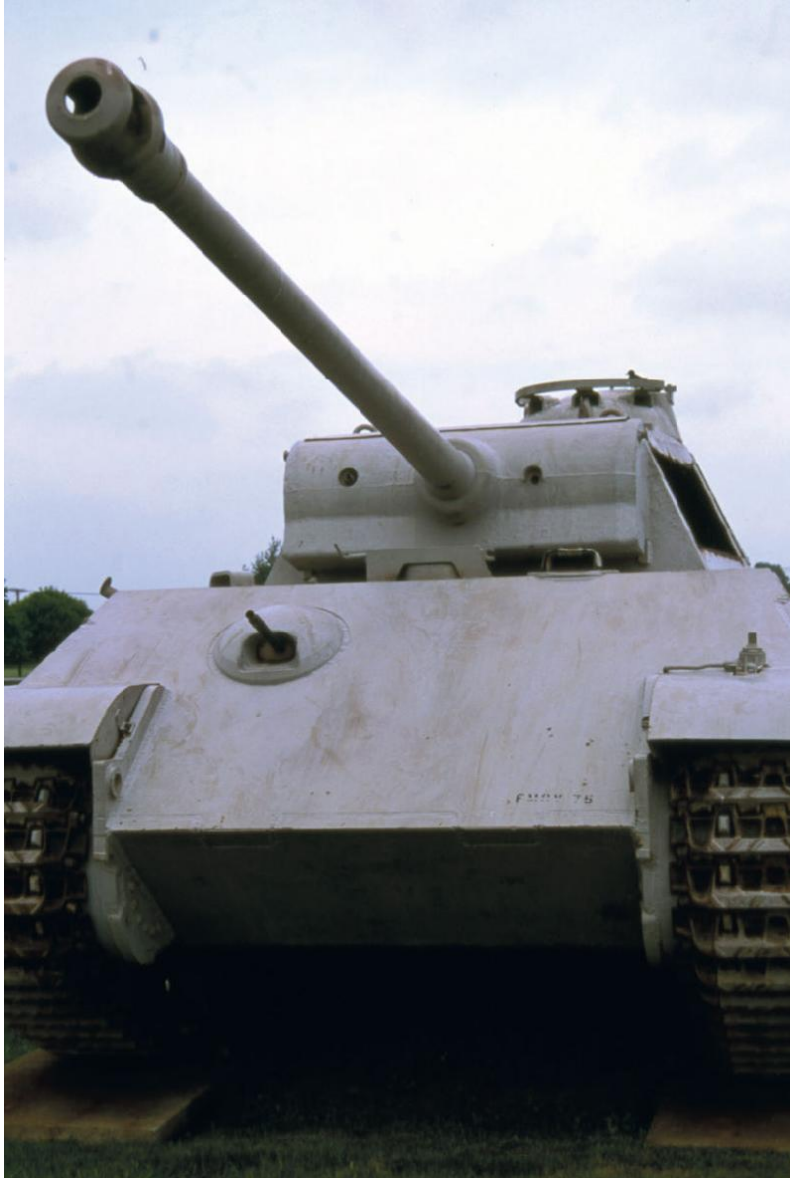
A PzKpfw V Panther on display at the Aberdeen Proving Ground Museum in Maryland, United States. A serious problem in the Panther was the final drive, which had a nominal life expectancy of 1,500km, but which in practice was sometimes as low as 150km.
(AirSeaLand/Cody)

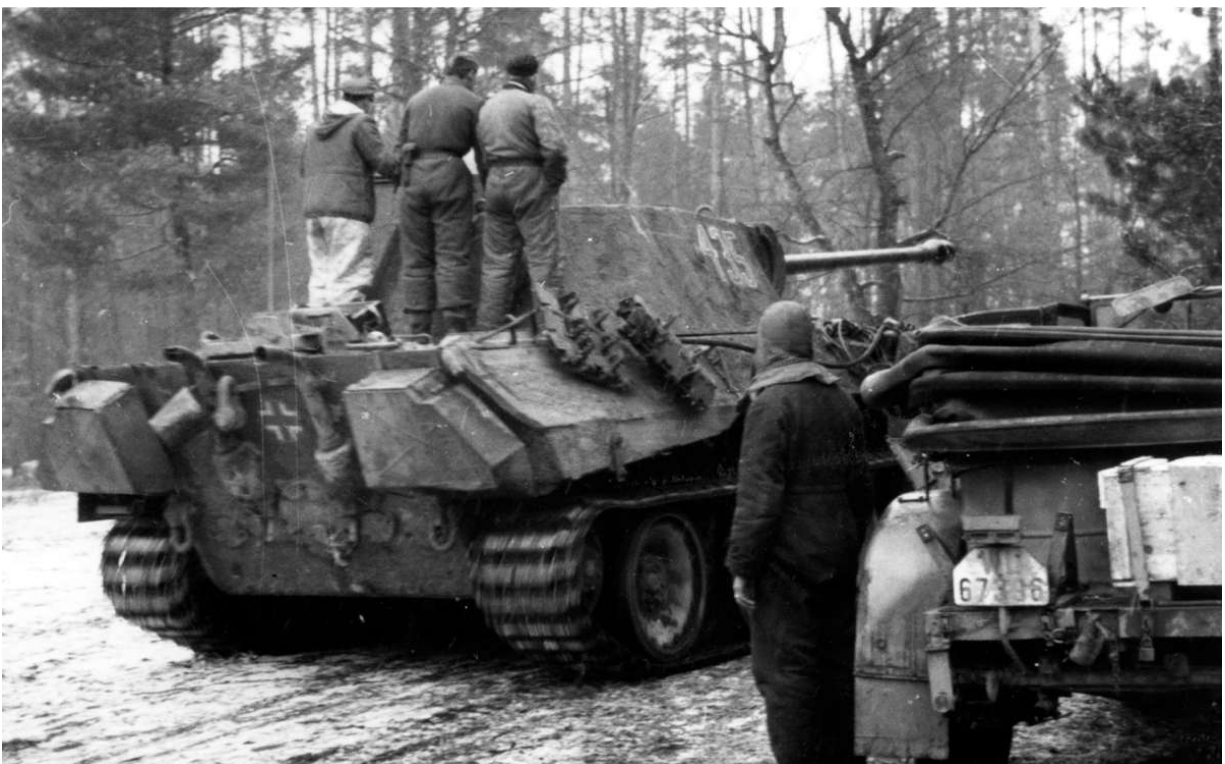
A PzKpfw V Panther seen in the winter of 1944–45. Later models featured large sheet metal guards fitted around each exhaust pipe. It was not uncommon for a passing infantryman to rest his hand unthinkingly on a superheated exhaust and lose most of the skin off his hand.
(AirSeaLand/Cody)

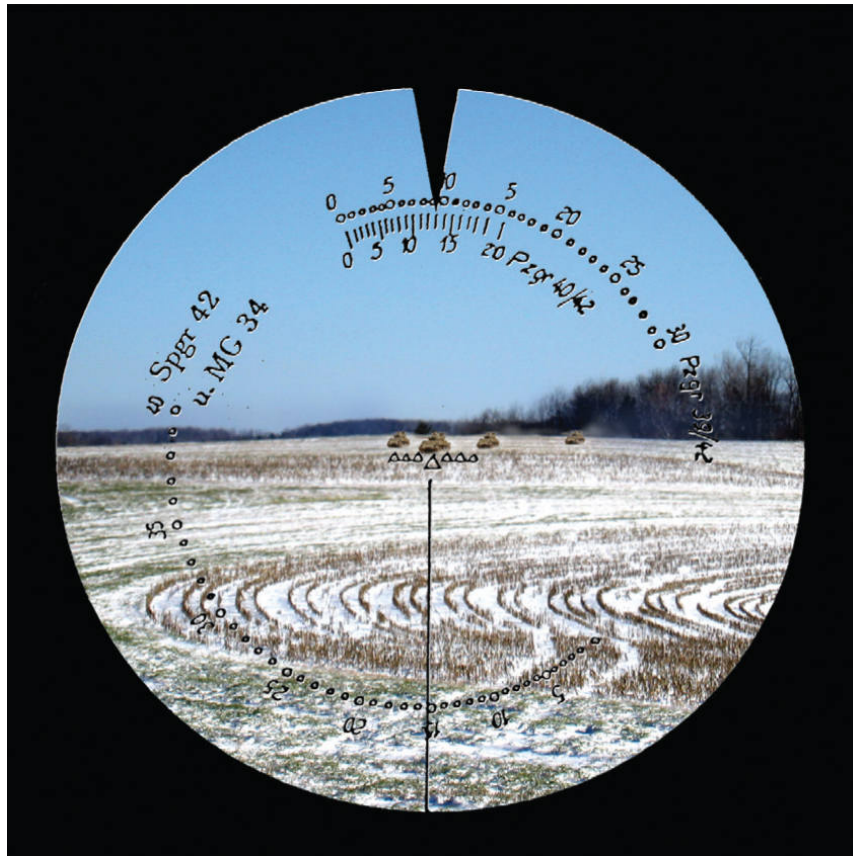
PANTHER GUN SIGHT VIEW

A view of Sherman tanks through a TZF 12a set at 2.5 power. The enemy tank is 900m away.

The Panther Ausf G tank's 7.5cm KwK 42 gun was aimed through a TZF 12a monocular telescope in place of the binocular TZF 12 used in the Panther Ausf D. The telescope operated at two magnifications, 2.5× and 5×, with the lower magnification being used for general observation and the higher magnification for precision aiming. The TZF 12a telescopic sight had an engraved reticle consisting of an aiming triangle in the centre with smaller triangles on either side. The gunner placed the target at the apex of the centre triangle. This reticle provided a limited stadiametric ranging capability in the same way as that described for the Leitz TZF 5b in the previous chapter. For example, a Sherman tank was about 2.7m wide, so if the front view of the tank filled the centre triangle, it was about 670m away. The small graduations around the periphery of the reticle were to

help adjust the weapon, depending on the weapon and type of ammunition being used. The gunner would dial in either the machine-gun or main gun graduations, and set the range of the ammunition type at the apex of the upper triangle, seen here set at 900m for the Pzgr 39/42 armour-piercing projectile. This would adjust the telescope relative to the gun to provide for the modest change in elevation needed to compensate for the drop of the projectile at varying ranges.

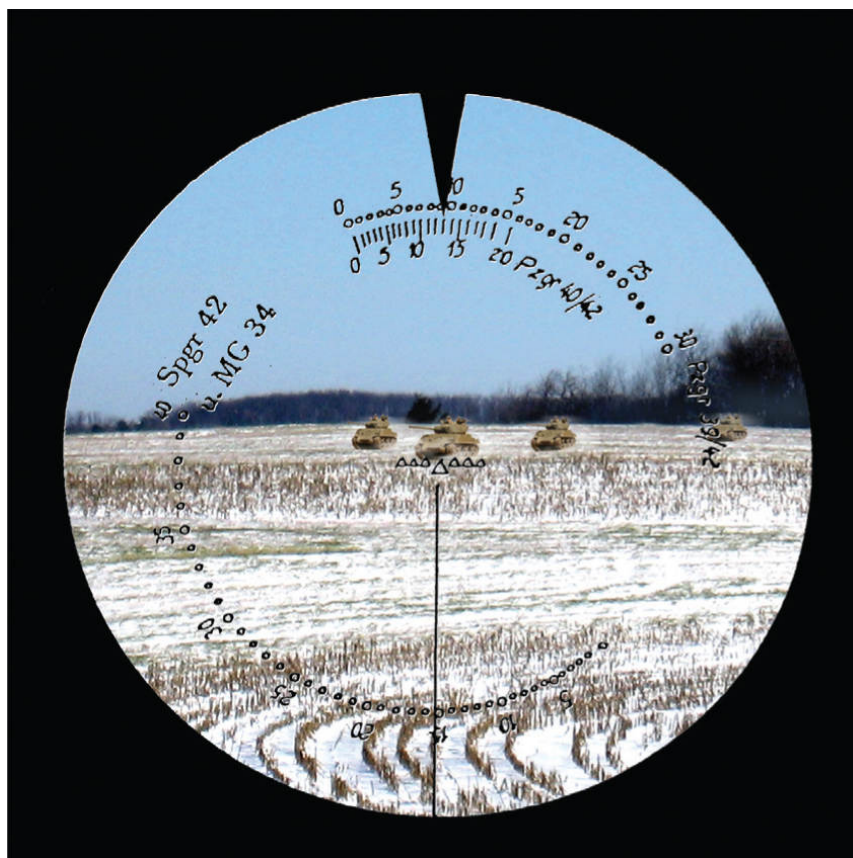
The view through the same gun sight but set at 5 power shows a much clearer view of the enemy tanks.

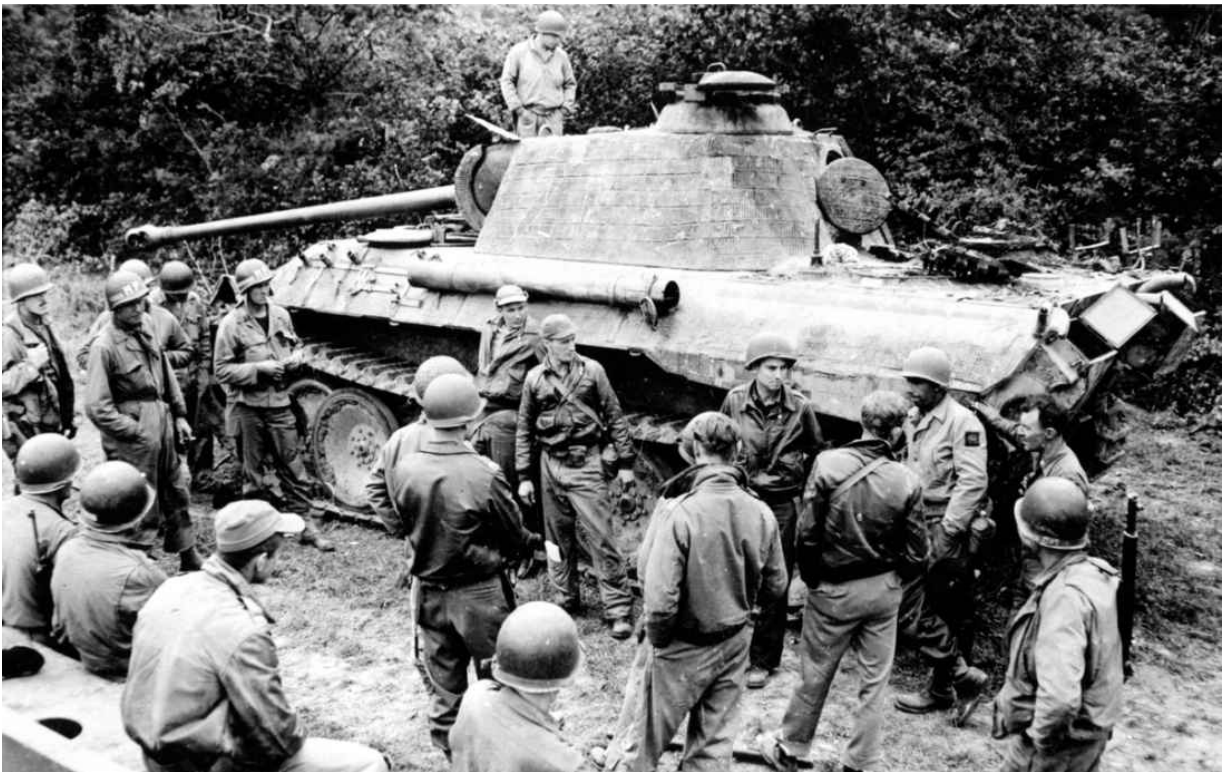
The presence of US P-47 fighter pilots alongside these US infantry likely indicates that an air strike was responsible for the destruction of this vehicle; note the large hole in the engine compartment armour. (AirSeaLand/Cody)

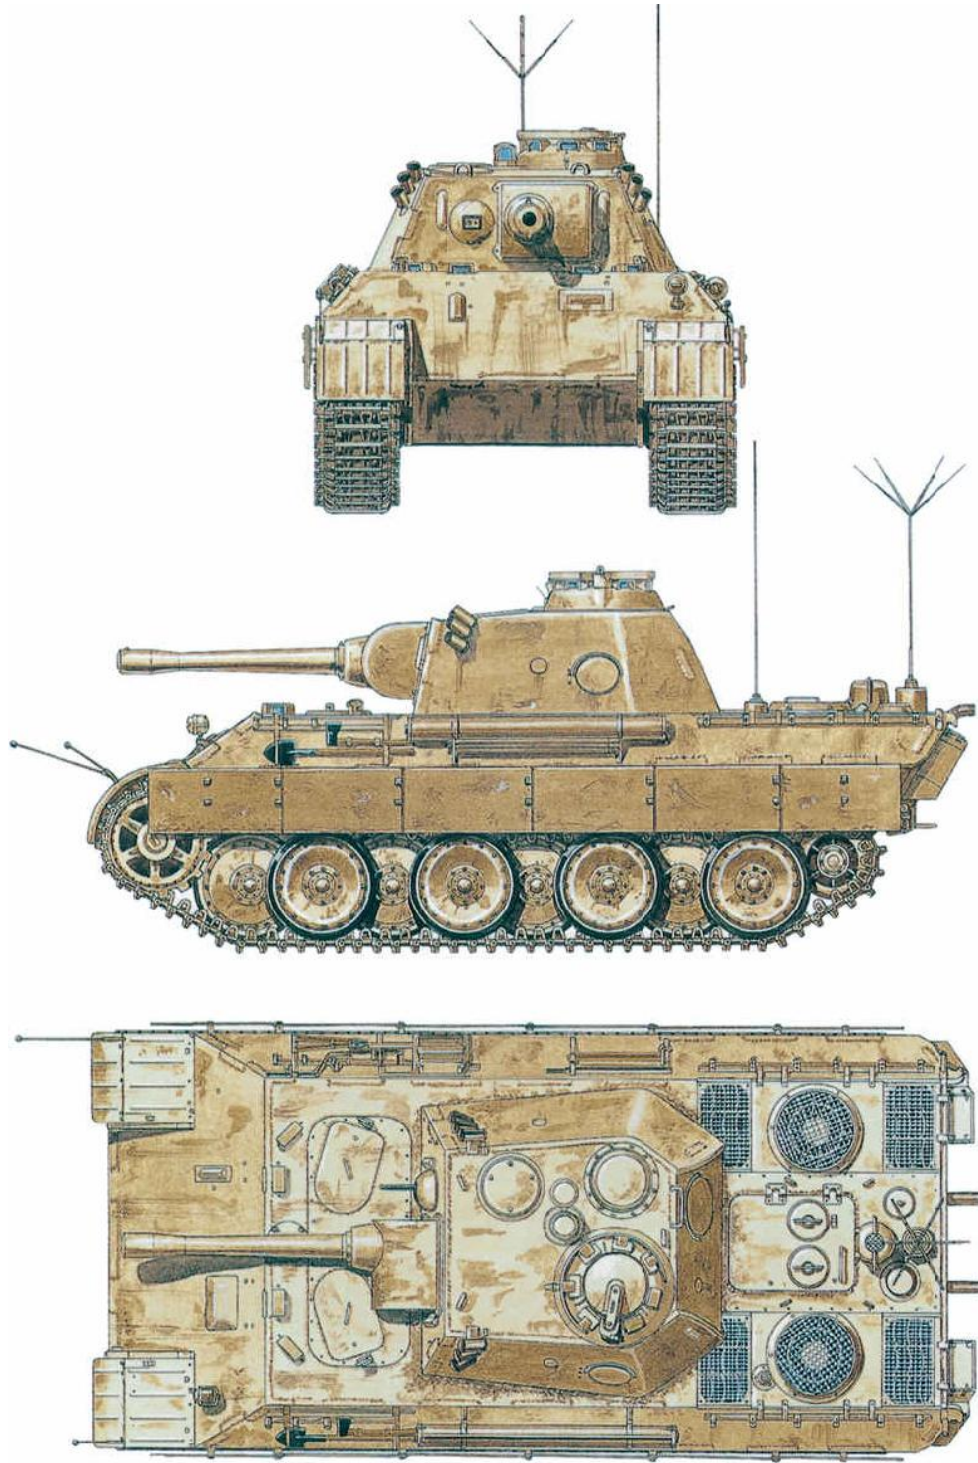
PANZERBEOBACHTUNGSWAGEN PANTHER, 1943

The Artillerie requested an armoured observation vehicle with the characteristics of a battle tank that could replace the lightly armoured Beobachtungswagen based on the semi-track chassis. Initially, a series of Panzerbeobachtungswagen were created using rebuilt PzKpfw IIIs, but the Artillerie wanted a larger vehicle based on the new Panther chassis. Design

work was completed and a *Versuchsturm* (experimental turret) was mounted on a Panther chassis to undergo tests. Due to the high demand for Panthers for the Panzertruppe, the Artillerie were not allowed to order series production for the Panzerbeobachtungswagen Panther.

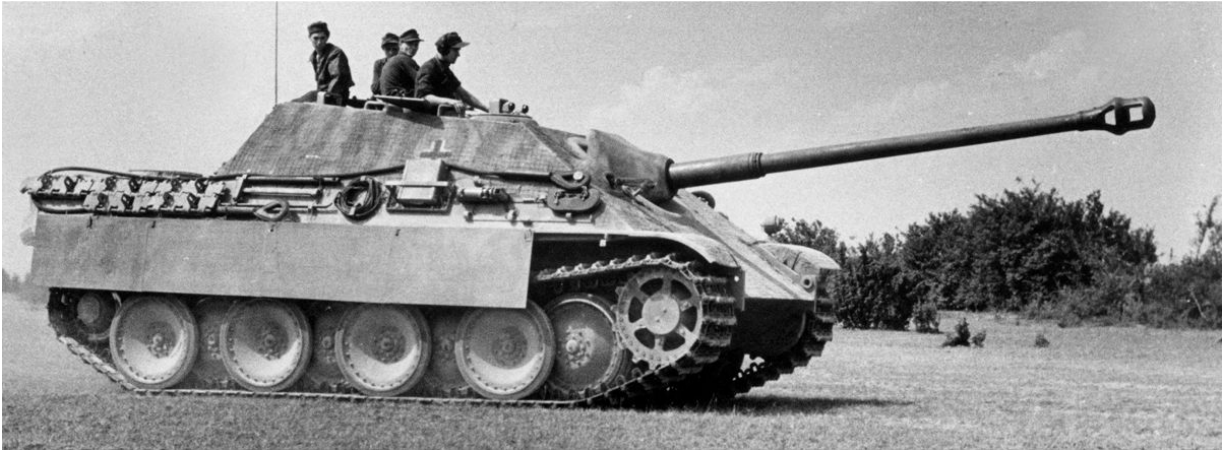
Only just over 400 of the Jagdpanther (Hunting Panther) SdKfz 173 tank-destroyers were produced during the war years. The Panther's turret was replaced with a fixed, open superstructure mounting the 8.8cm PaK 43 cannon. Other Panther variants included the Bergepanther armoured recovery vehicle, the Panzerbeobachtungswagen Panther (armoured artillery observation vehicle) and various self-propelled artillery designs.
(AirSeaLand/Cody)

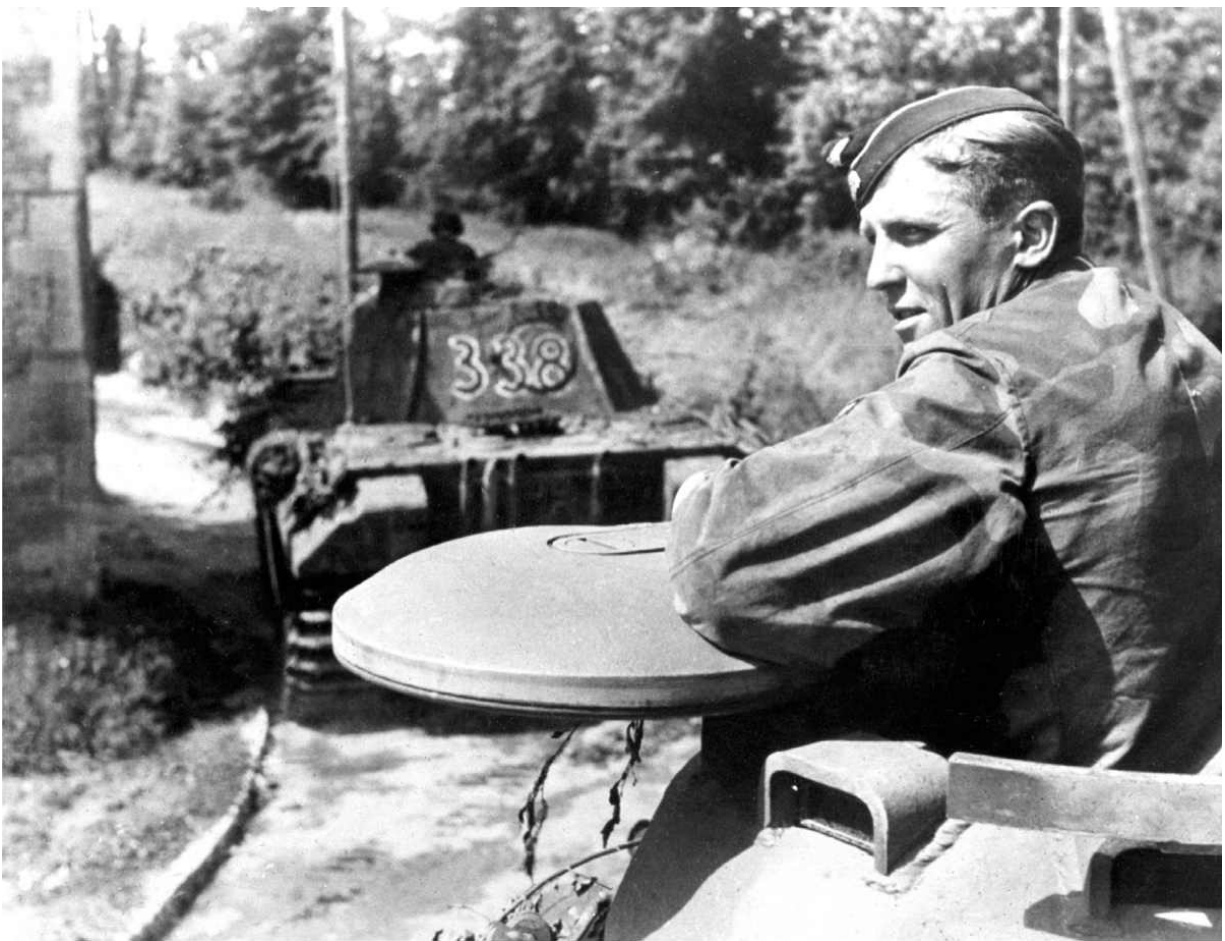
A Panther tank commander of the SS-Panzer-Regiment 12, 12. SS-Panzer-Division, scans the surrounding scenery. Note the armoured periscope by the side of his waist.
(AirSeaLand/Cody)

The Panther had five crewmen. The Panther tank commander (*Panzerführer*) was a lieutenant (*Leutnant*) and was stationed in the left rear of the turret below an armoured cupola, with all-around vision via a set of seven periscopic sights. A seat was provided for while riding inside the turret; when riding outside the cupola, the commander stood on a small footrest, hinged on the empty-round bin. German tank commanders were regularly provided with a set of binoculars for long-range target search. The cupola had a simple frame mount for attaching an MG 34 light machine gun for anti-aircraft defence, but the German tactics did not place as much emphasis on machine guns for use against ground targets as did the US Army. The Panther commander instructed his crew via an intercom system (*Fusprech*). In contrast to US and British practice, the radio was positioned in the hull next to the bow gunner, who operated the transceiver at the instructions of the commander.

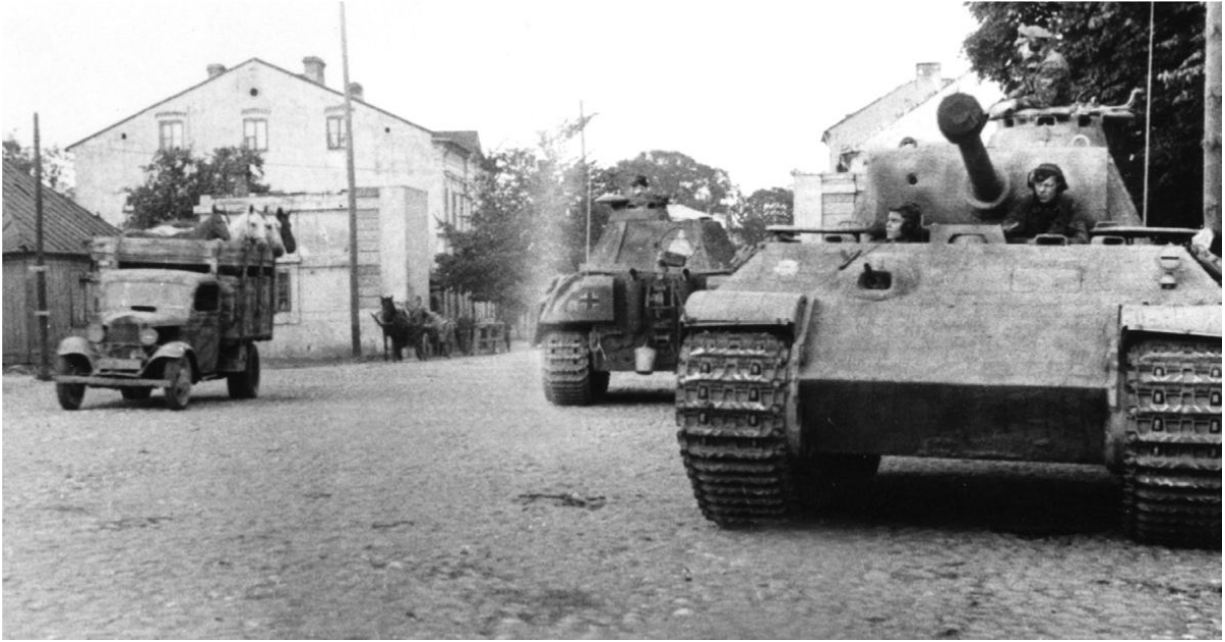
A PzKpfw V Panther unit pauses in a village. On the front right (as viewed) we see the driver, while on the left is the radioman, who also operated the bow machine gun.
(AirSeaLand/Cody)

The driver (*Fahrer*) sat in the left front of the hull. Beginning in October 1944, the driver had a second seat added. The basic one was for operating the Panther in combat conditions with the hatch closed, and the new one was in an elevated location for road travel with the hatch open, the driver riding with his shoulders outside the hatch for better visibility. The driving controls could be adapted for the closed and travel positions and consisted of steering levers on either side of the driver's legs, a gear lever and a handbrake. After the commander and gunner, the driver was the most important and senior member of the crew since German practice was to encourage driver initiative in moving and positioning the tank, based on the commander's general instructions. When in closed combat position, the driver had a traversable periscope. This had been adopted on the Ausf G in place of an opening armoured hatch in front of the driver, which compromised the armour integrity of the glacis plate. British evaluations of this sight considered it inadequate.

The final member of the crew was the radio operator (*Funker*), who sat in the right front corner of the hull opposite the driver. His main role was to operate the tank's Fu 5 SE 10U radio transceiver, which was located to his left. The Fu 5 was an AM radio with two receivers, one with preset frequencies and the other to dial up channels. In addition to operating the radio, he also manned the bow machine gun, an MG 34 in a ball mount sighted through a KZF 2 cranked sight. Besides the machine gun sight, he also had an episcopes which covered the right front quadrant of the tank. The position was not well configured as the episcopes orientation prevented the gunner from using it to locate targets for the machine gun, and the machine-gun sight had a very narrow field of view.

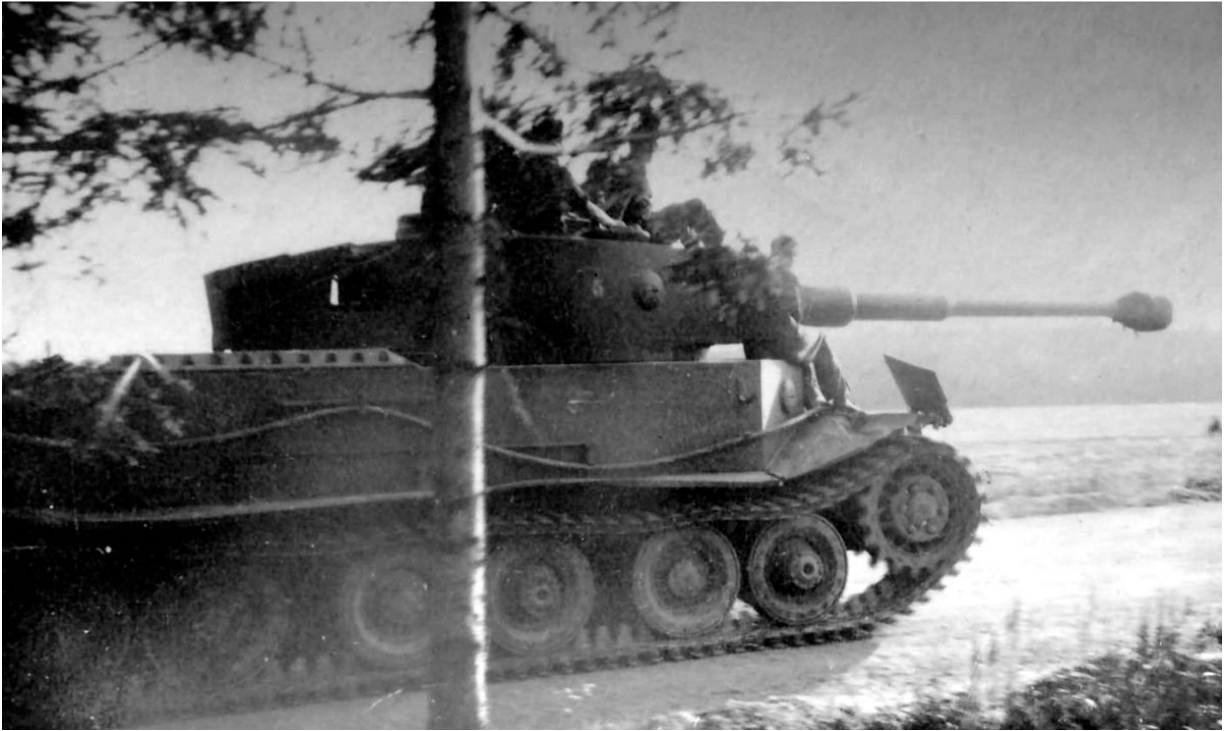
In autumn 1940, Prof Dr Ferdinand Porsche was commissioned to develop a 45-tonne tank, later designated VK 45. 01 (P) – seen here. Later it was decided to mount an 8.8cm gun. Nibelungenwerk in Austria was awarded the assembly contract. (AirSeaLand/Cody)

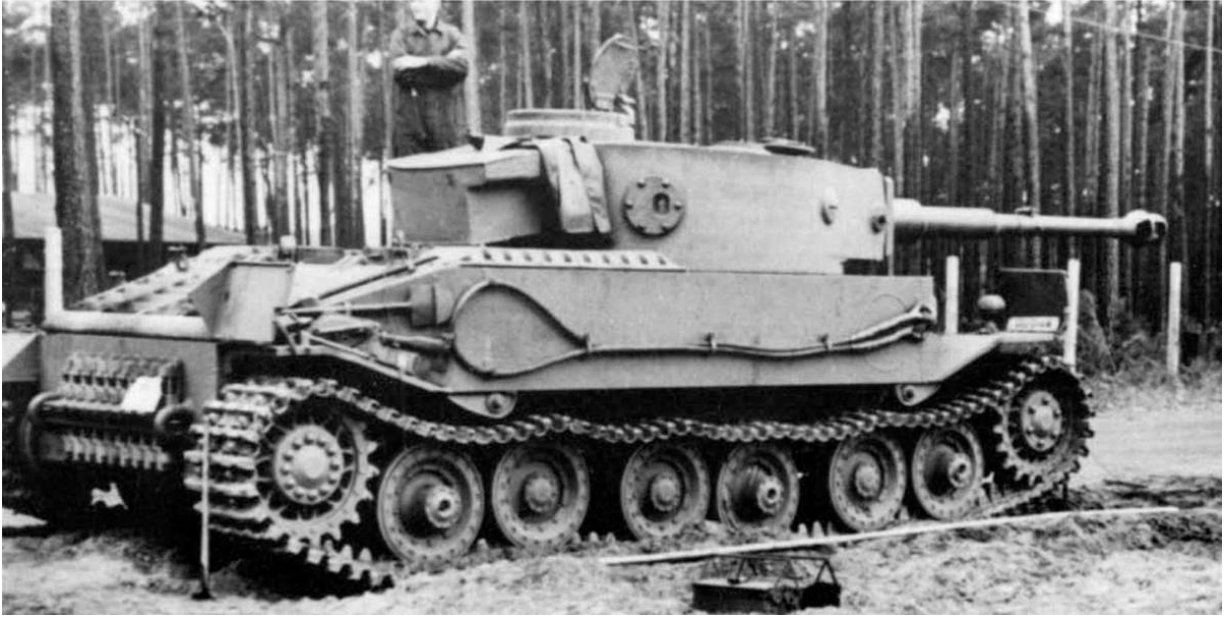
Another view of the VK 45. 01 (P). Porsche had used the nickname 'Leopard' for the previous VK 30.01 (P) design, and adopted the name Tiger for the new design. (AirSeaLand/Cody)

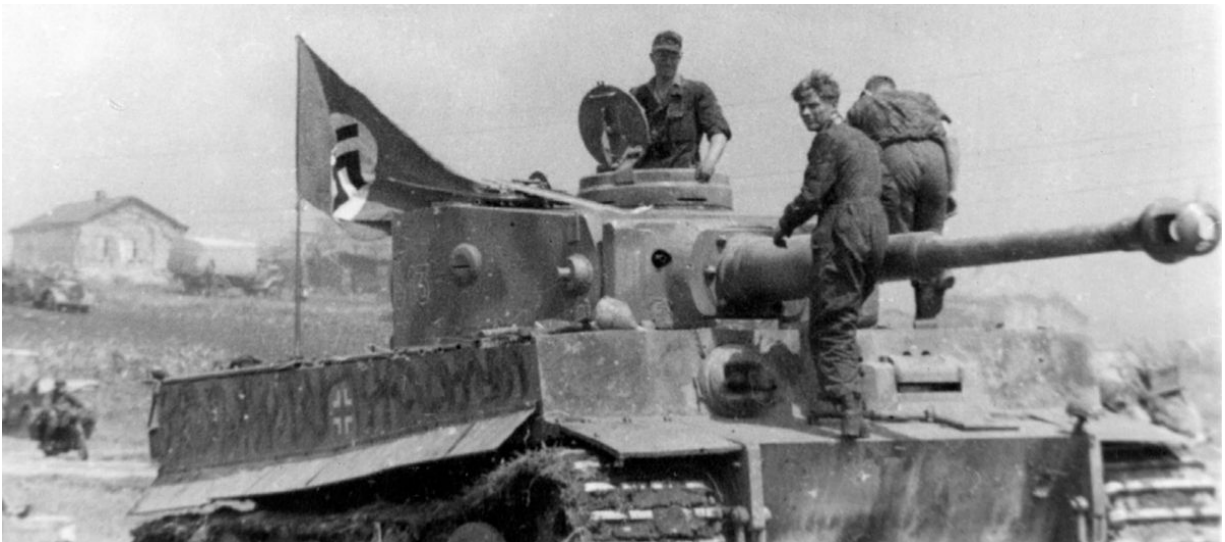
A Tiger I bedecked with a Nazi flag, theatre unknown. The protrusion just to the left of the gun manlet, on the turret itself, is a trunnion, used as an anchor point when lifting off the turret. (AirSeaLand/Cody)

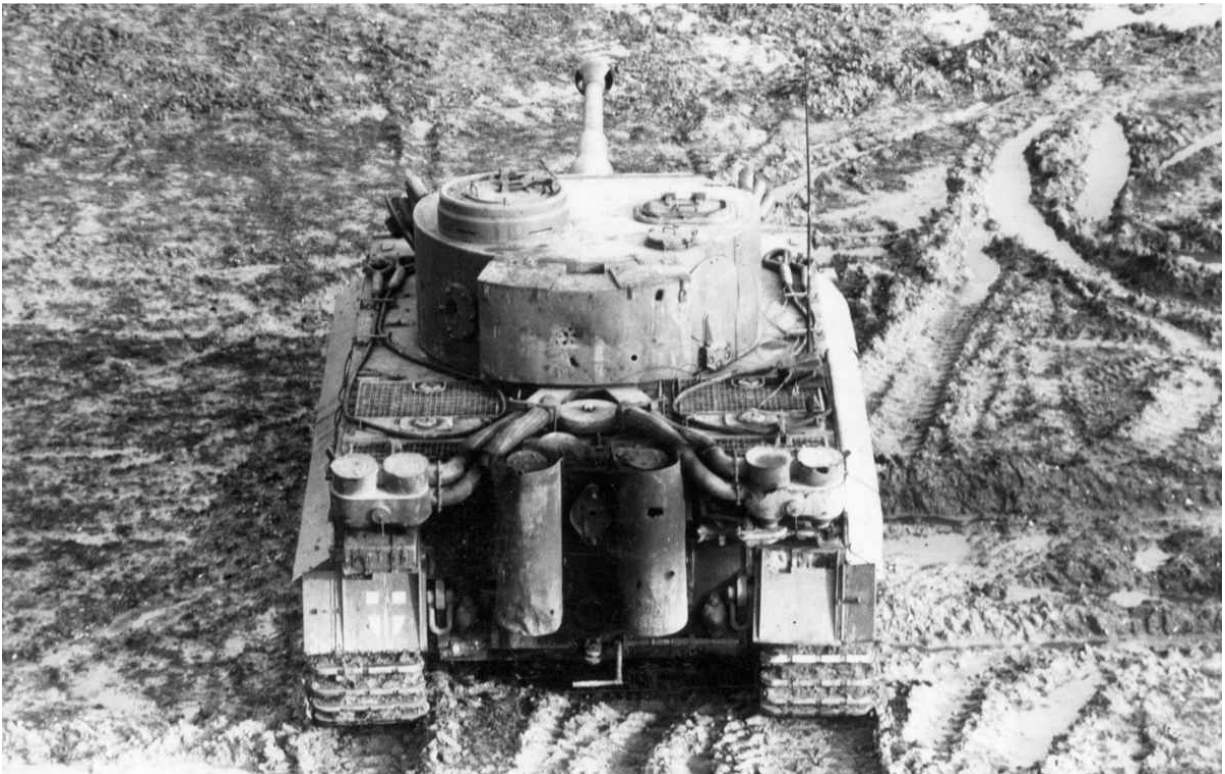
A captured PzKpfw VI Ausf E Tiger I. Note the very large heat shields over the exhausts in the centre rear of the vehicle, flanked by engine fans. (AirSeaLand/Cody)
